Allied Paper, Inc./Portage Creek/Kalamazoo River Superfund Site

Plainwell No. 2 Dam Area Reconnaissance Photographs

November 20, 2008

A compilation of photographs taken by Mike Erickson of ARCADIS and Sam Borries of USEPA

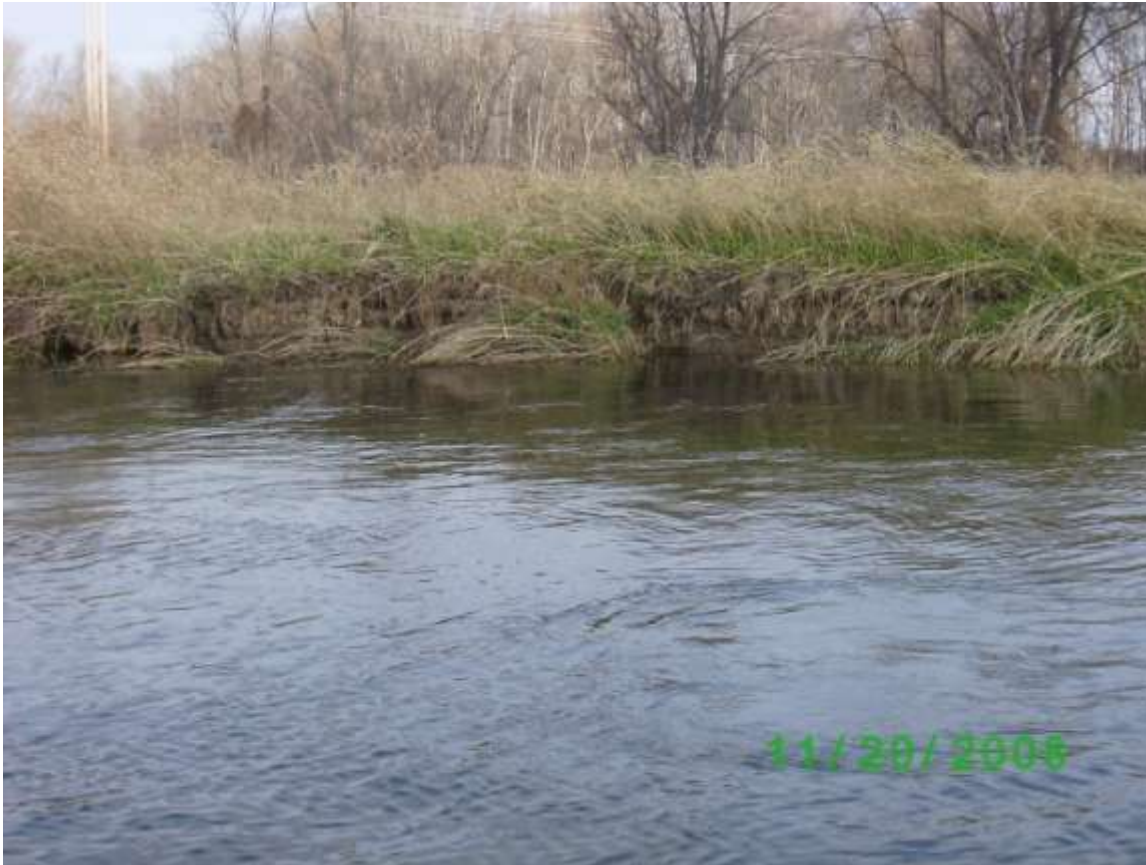
Bank soils.

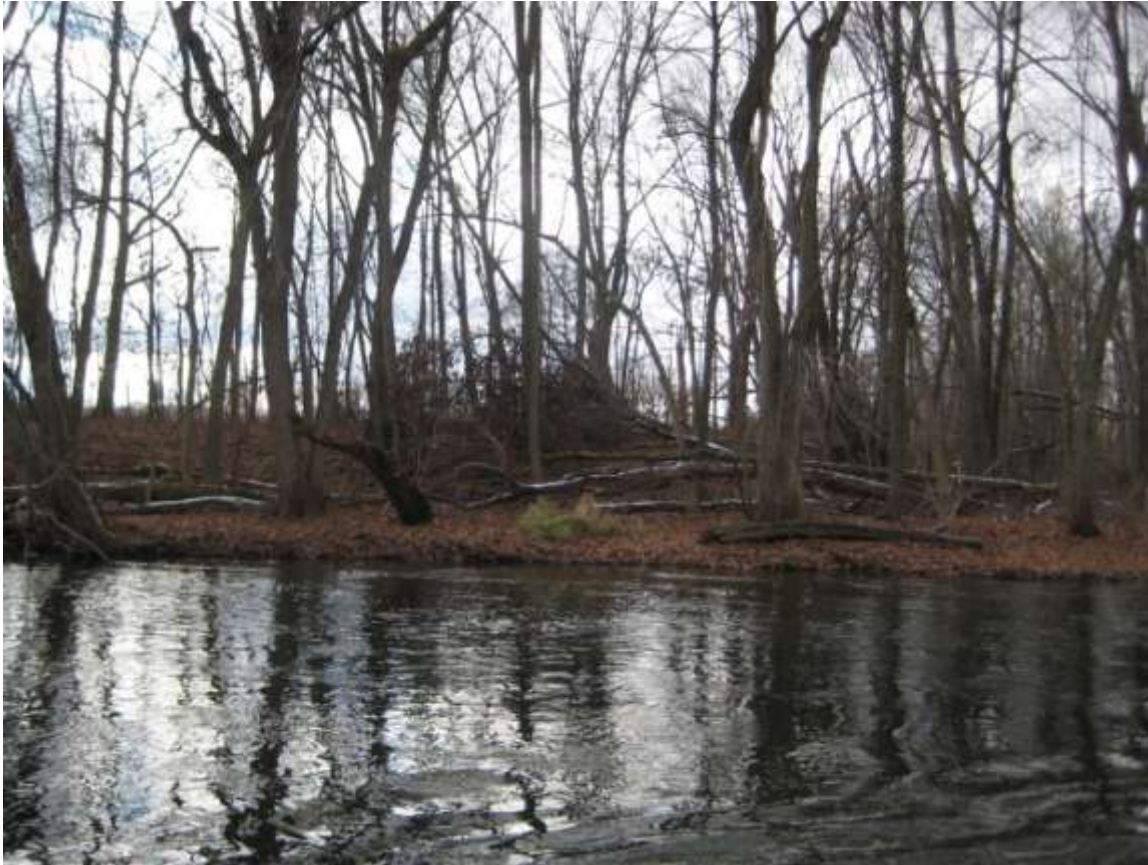
South bank.

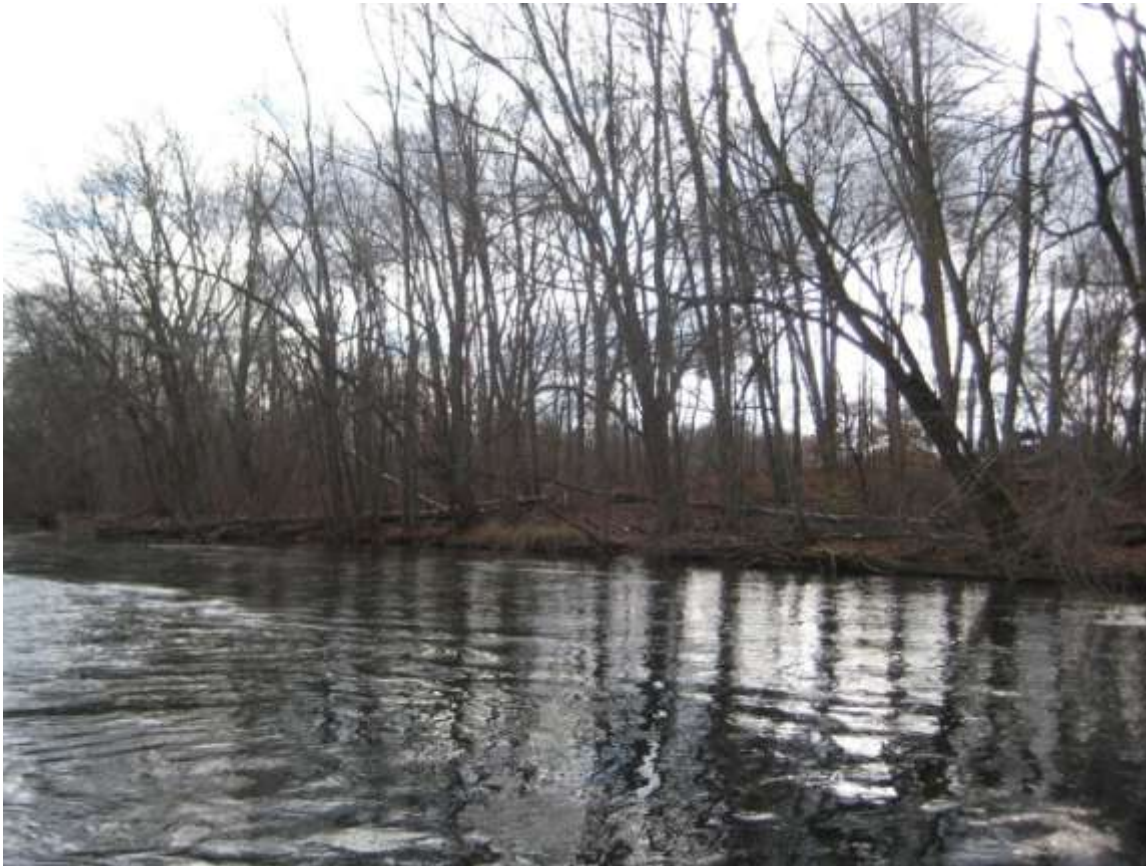
South bank.

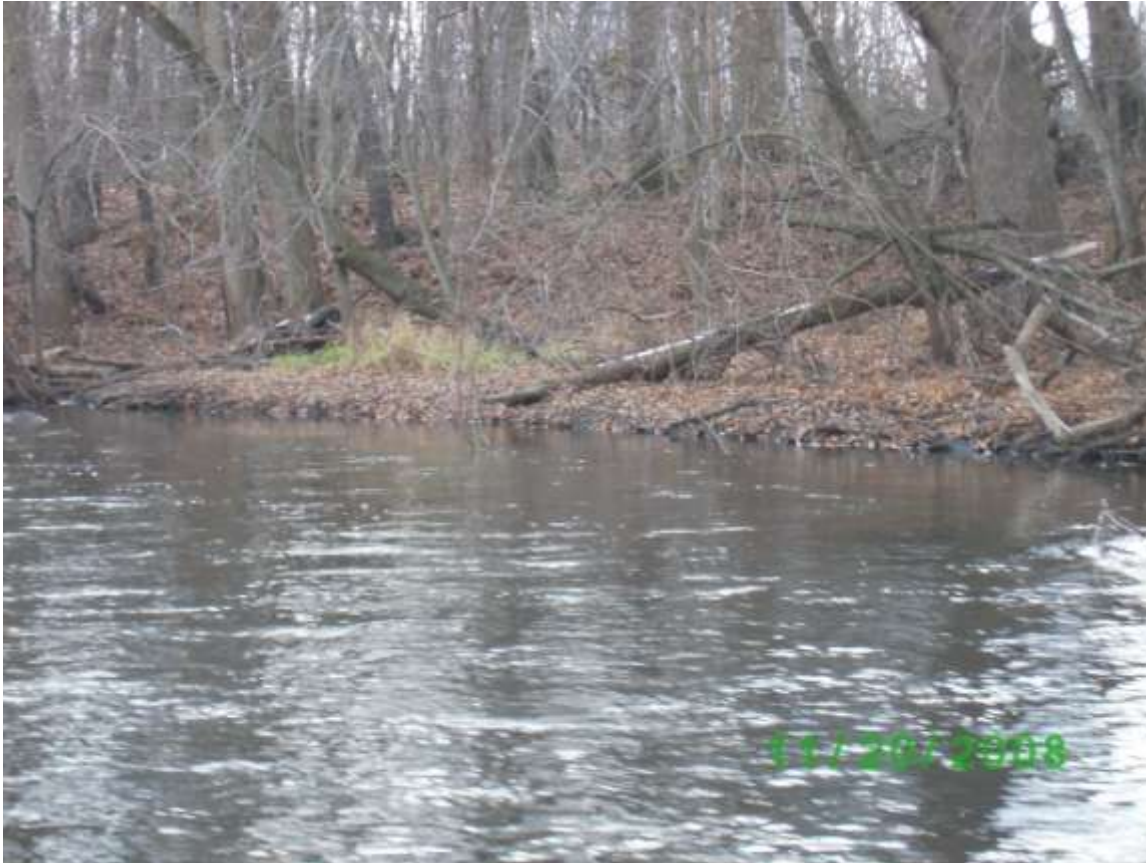
South bank.

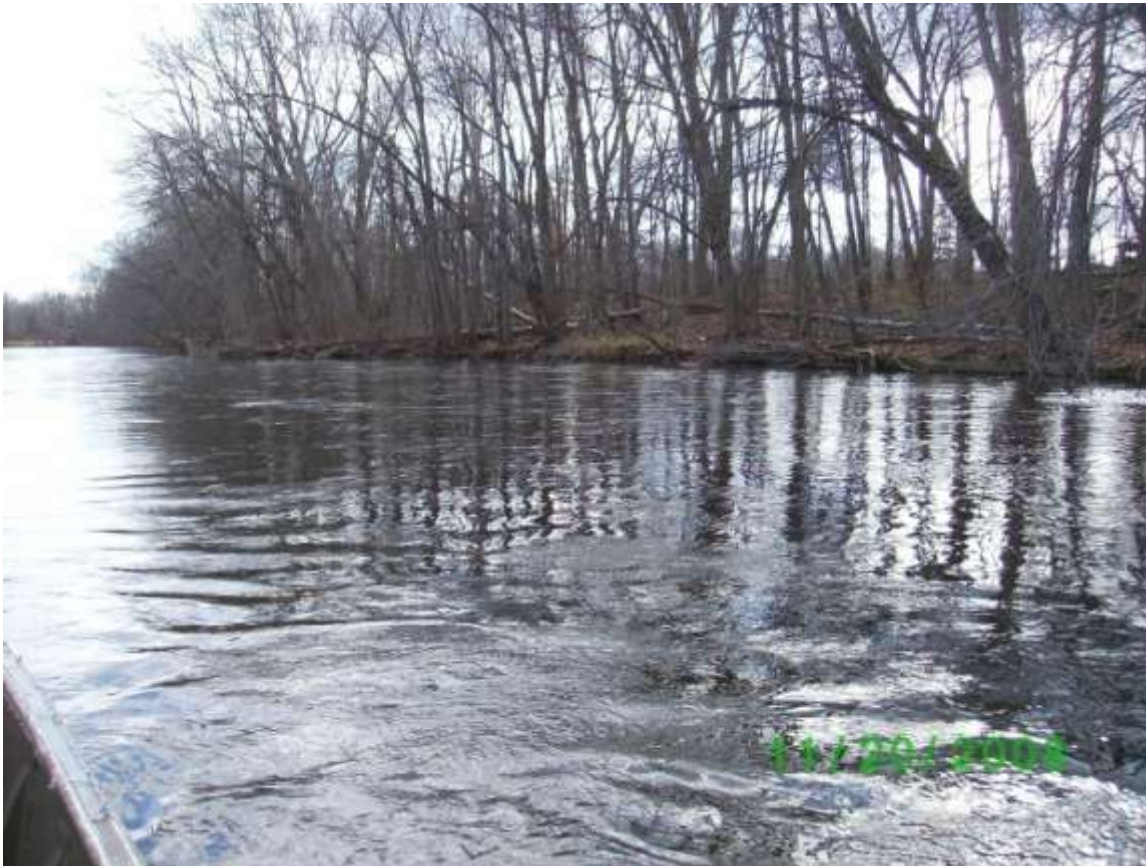
South bank.

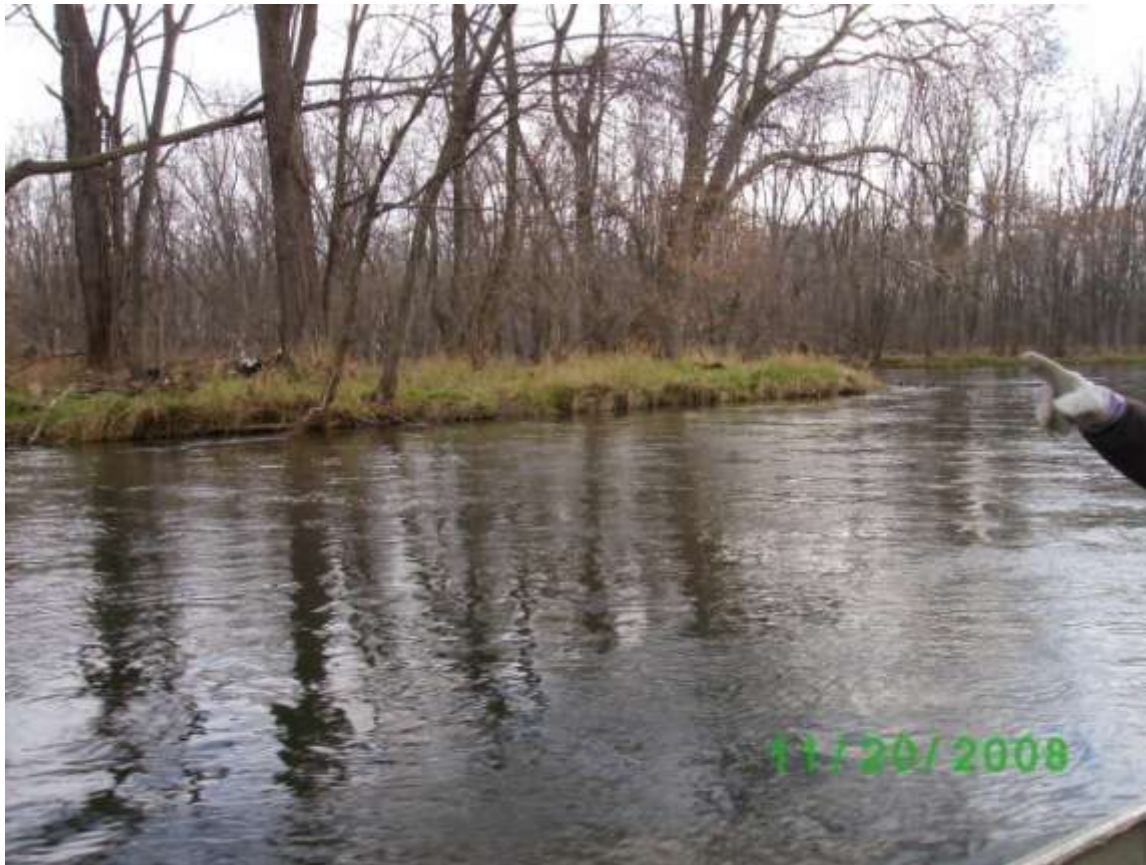
Upstream end of large island.

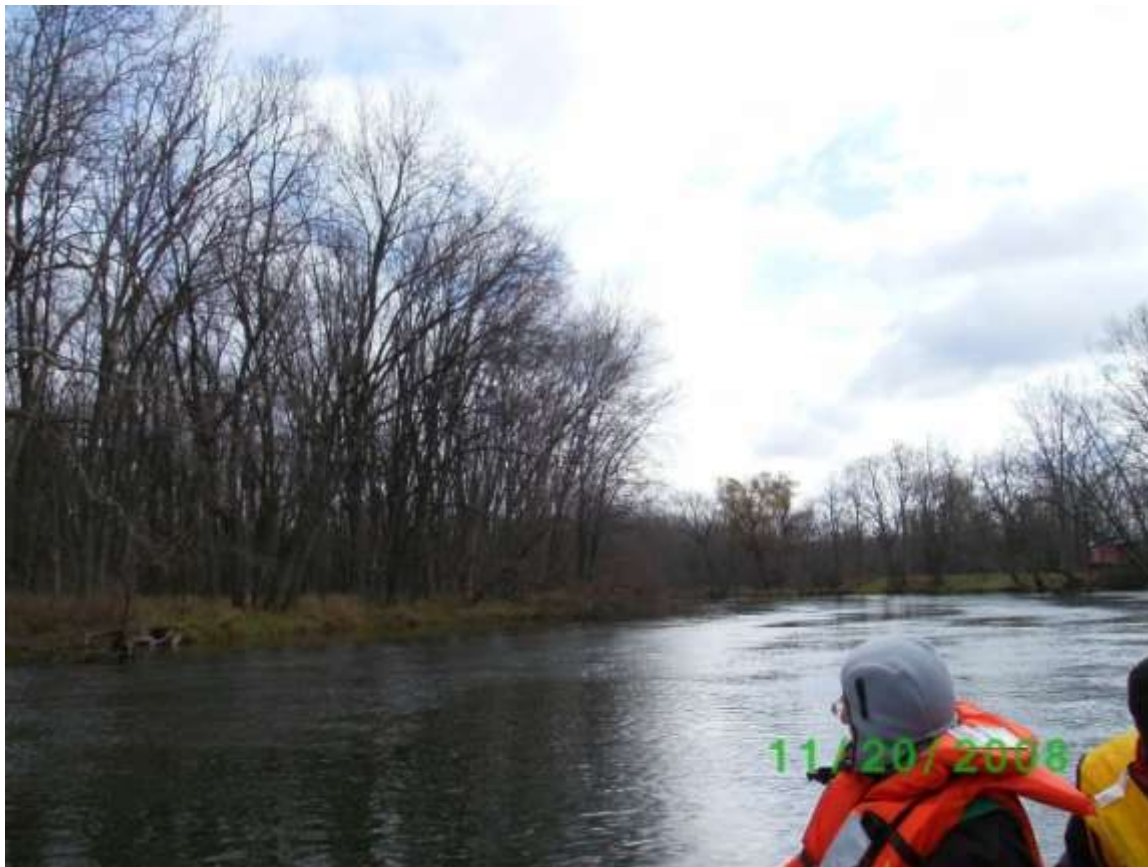
North bank.

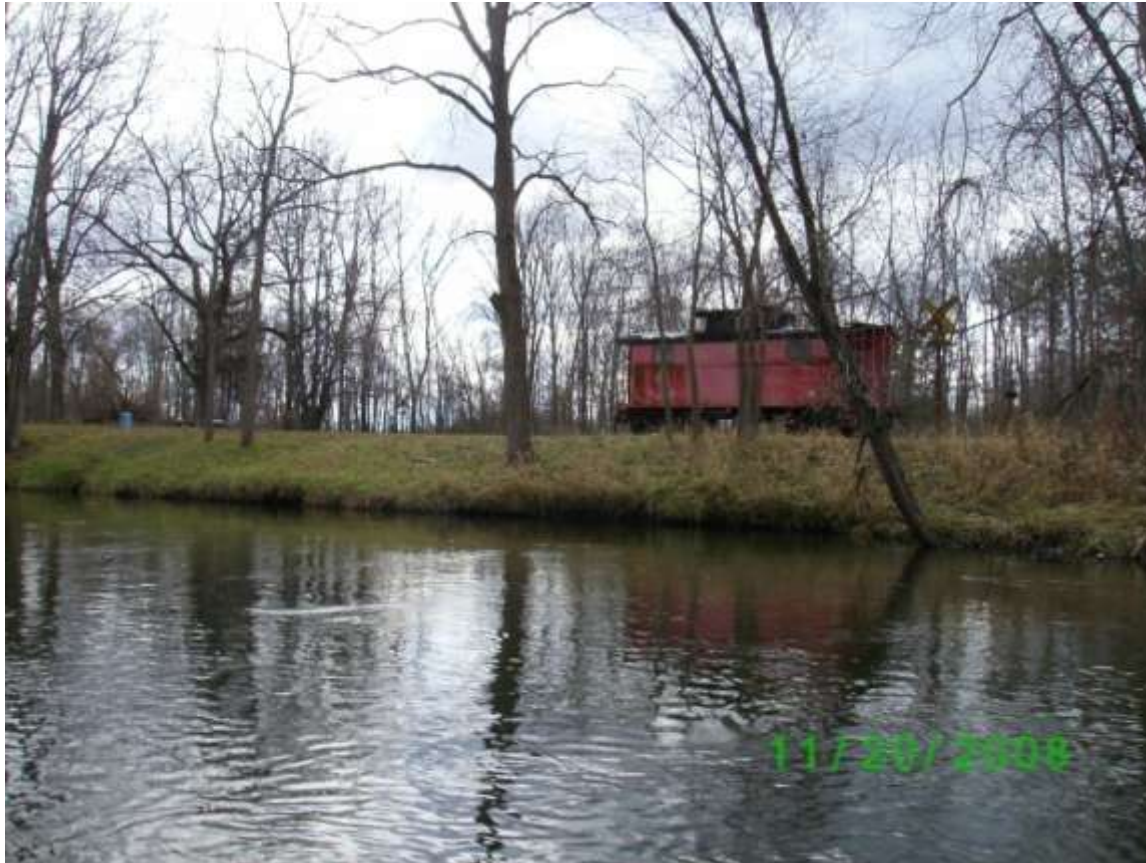
Caboose at private residence, south bank.

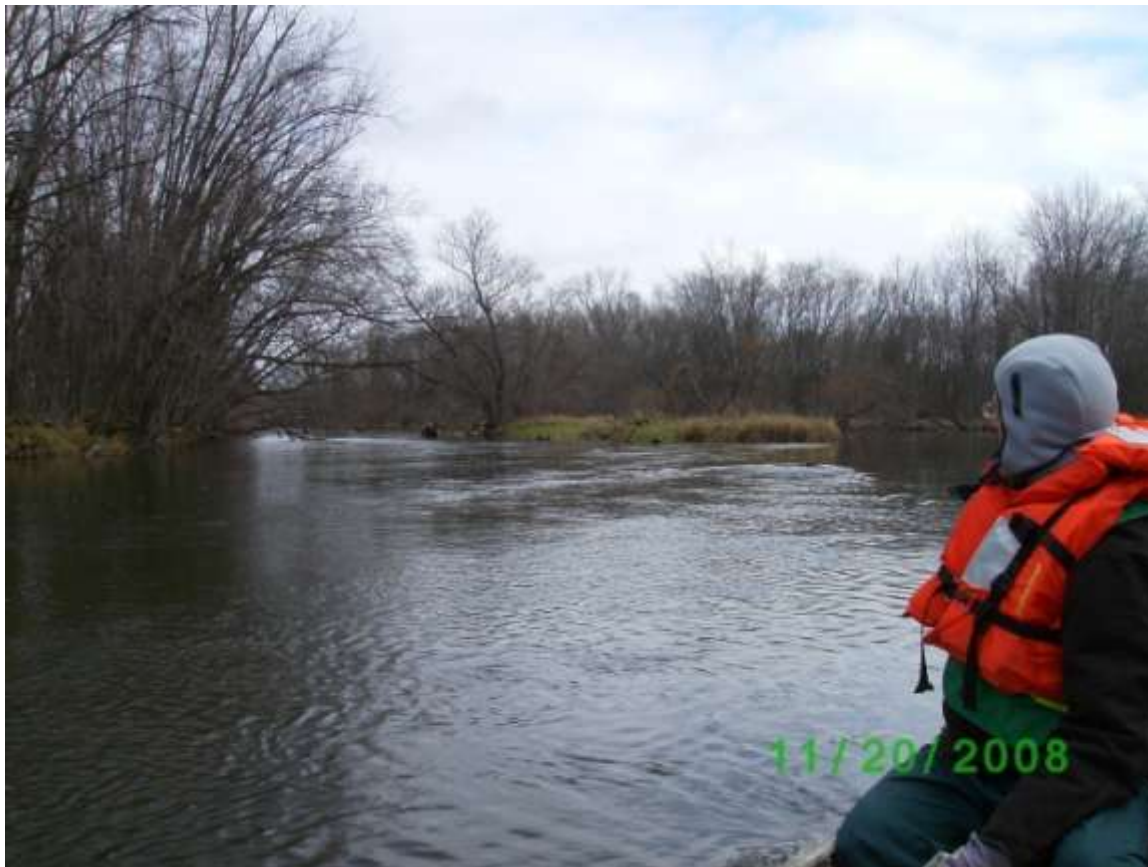
Small mid-channel island.

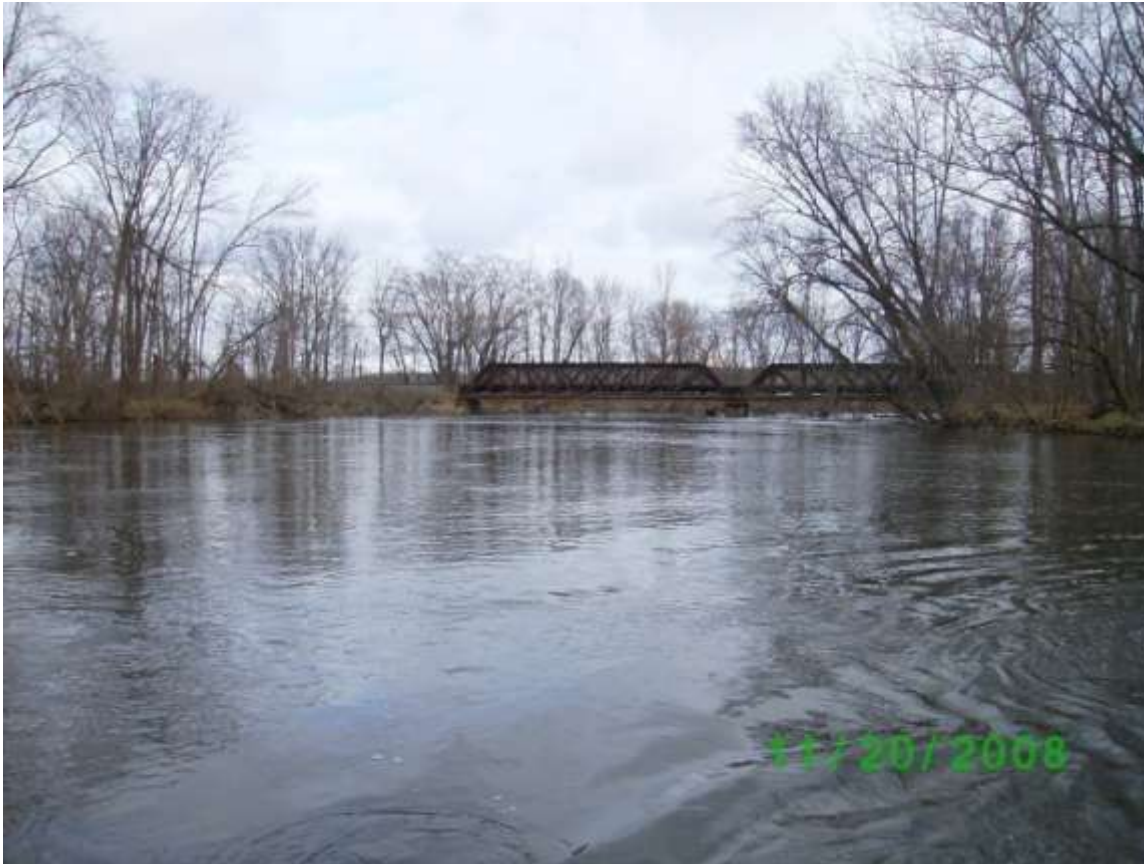
North channel around small island.

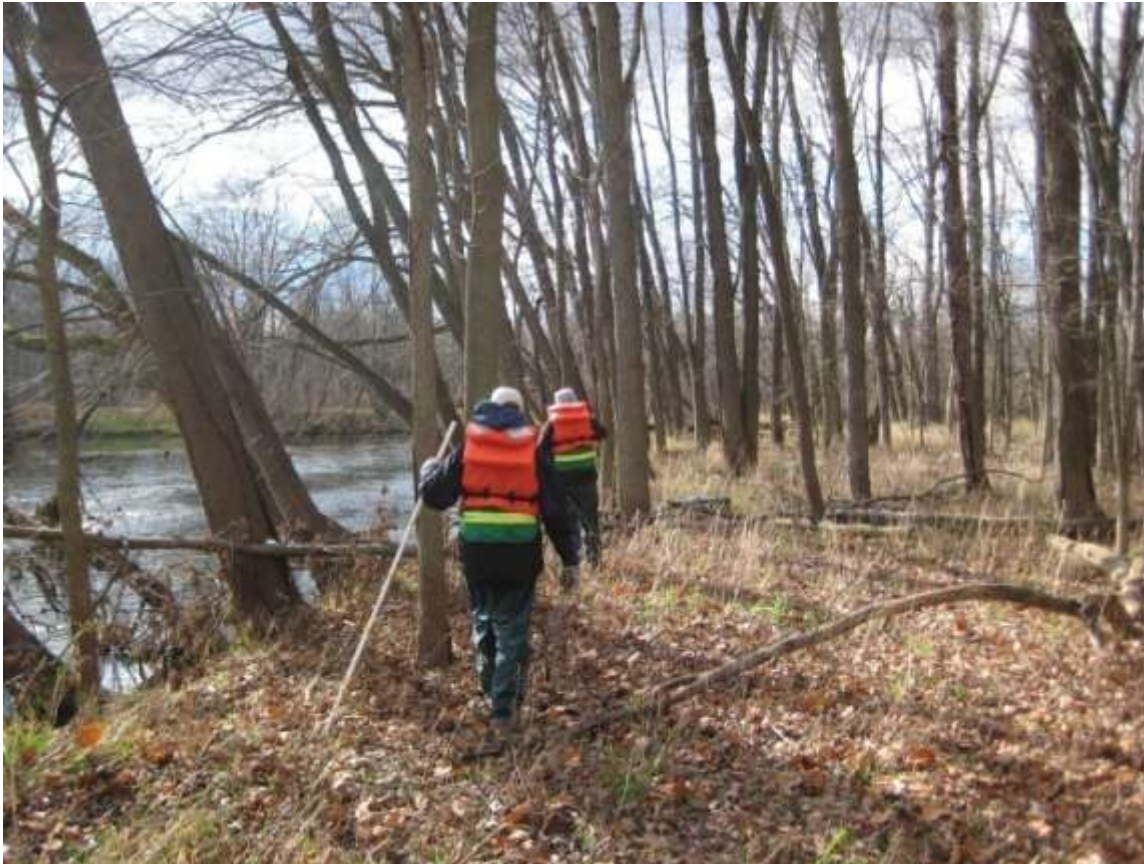
Floodplain bench along north bank.

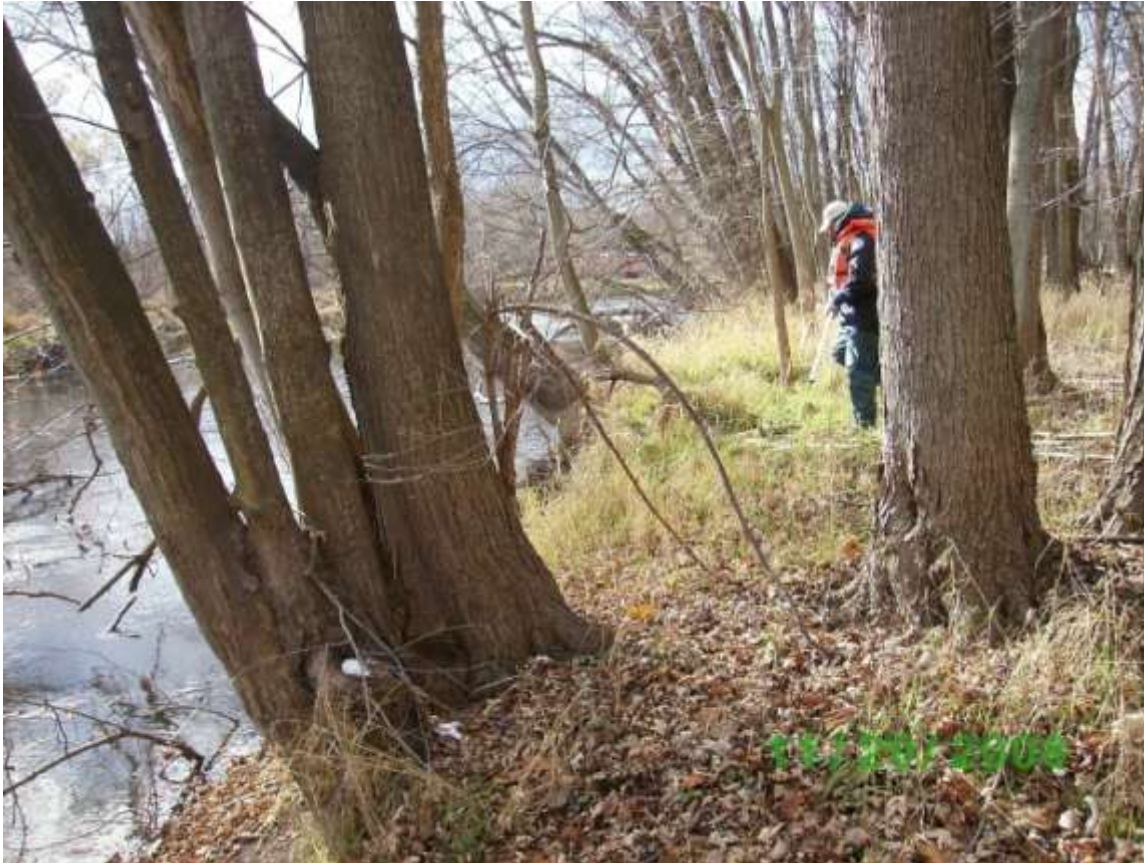
North bank.

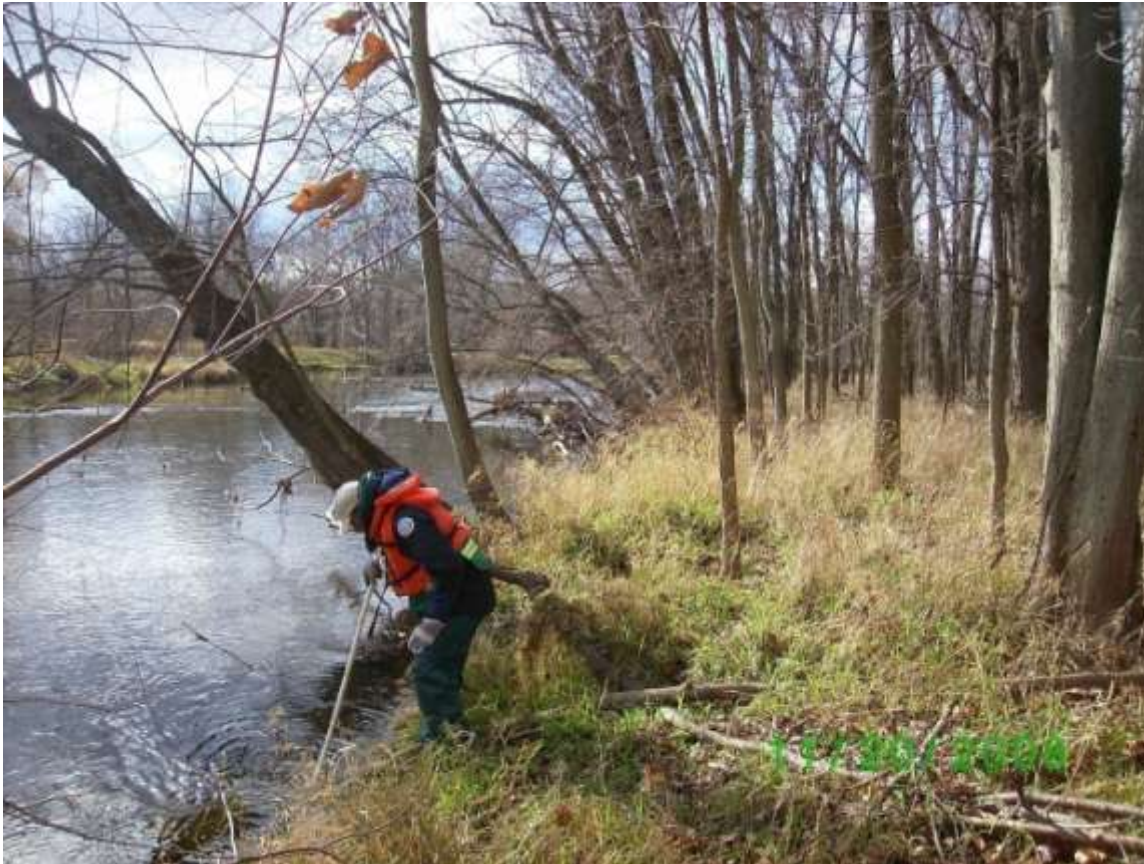
Large trees along north bank.

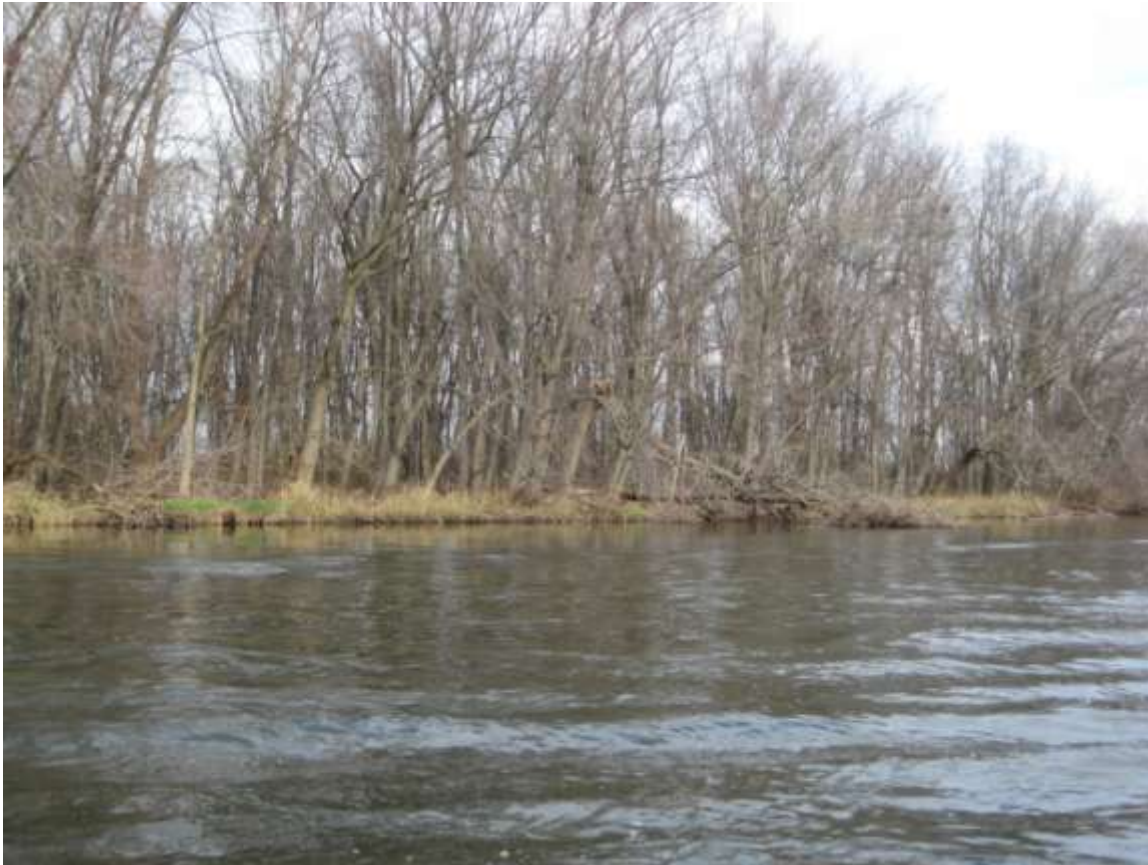
North bank.

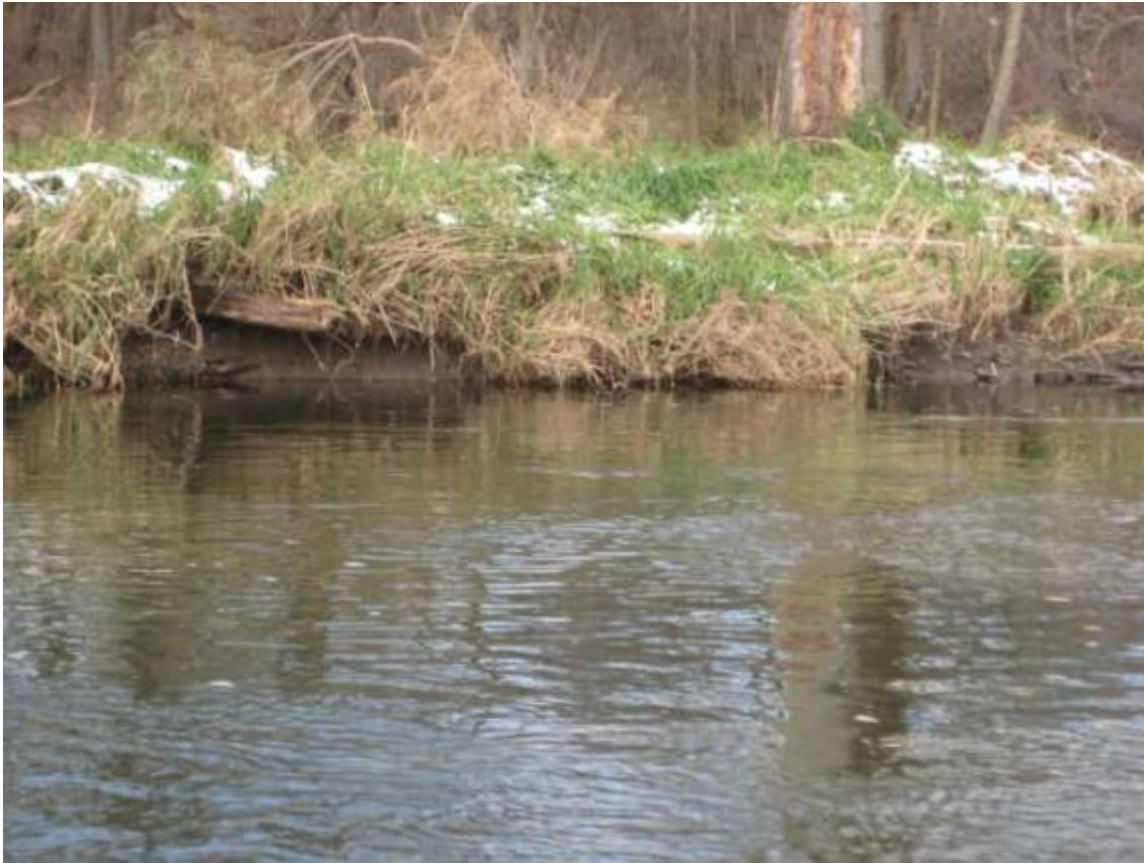
North bank.

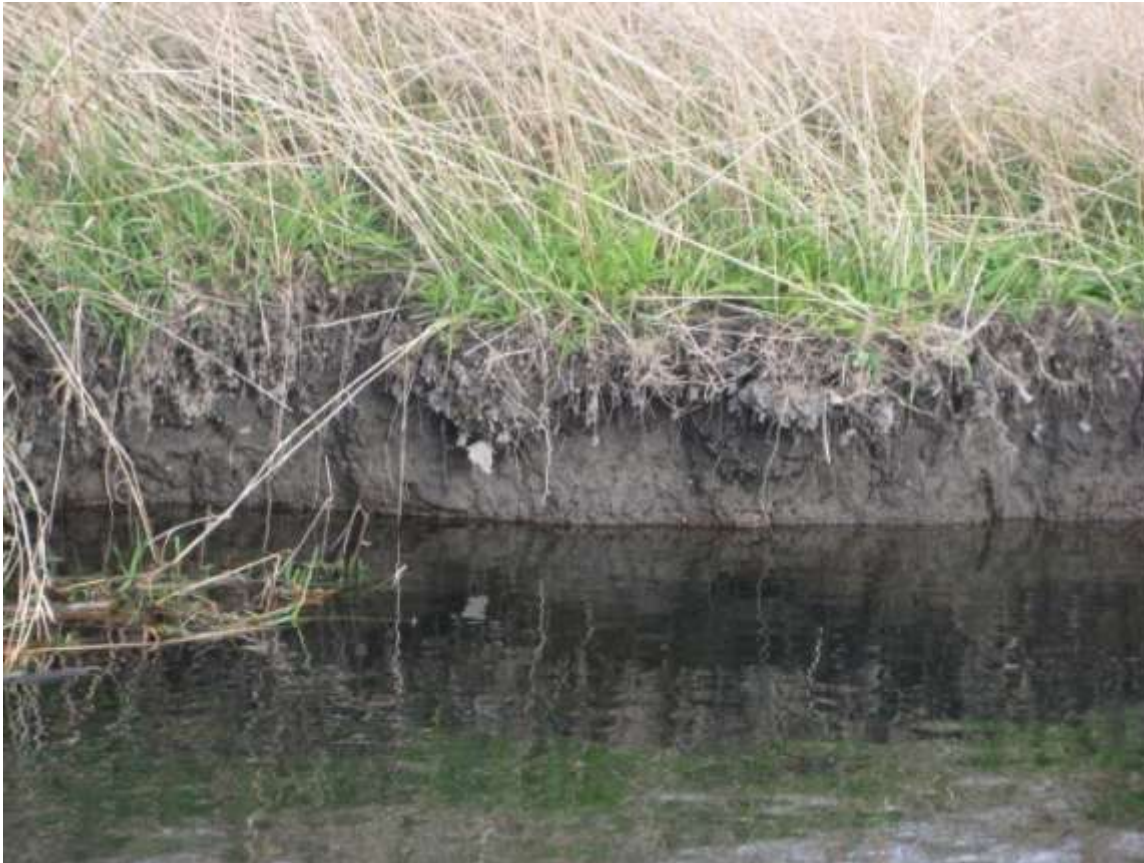
Banks of large island.
